Renovering af vinkelgear

Angle-Drive for the Speedo – a simple part but a real nuisance

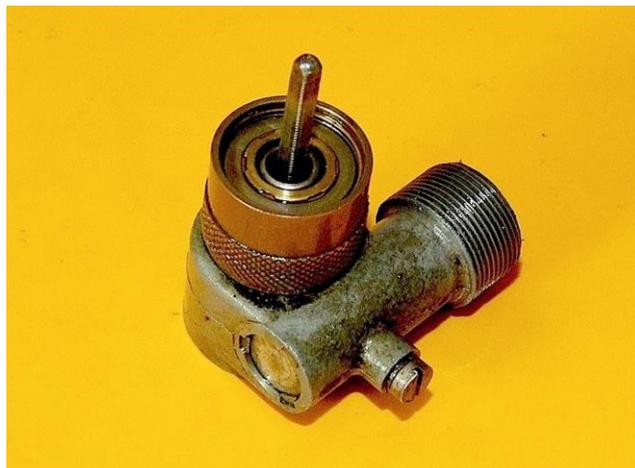
This is the unrestored original from my 4A:

A common fault with these drives is that the flexible **wire-stub**, seen sticking proudly upwards in the photo above, is missing. Sometimes it's stuck in the transmission.

I set about opening up the drive, to find out how to fix in the new wire-stub. Smiths fastened these together by "peening". The process deformed small areas of the body so as to retain the steel discs, that give the thrust-faces for the gears. You can just about see this, in three places, in the photo above.

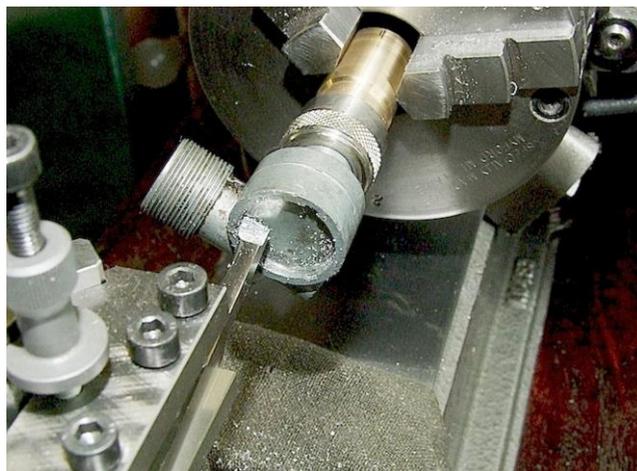
Here I am using a better method to get access to the main bevel-gear:

Doing this allows me to open the drive quickly, and cut a groove for a circlip to hold it together again, all in one operation. I do the same thing to get at the spiral-gear.

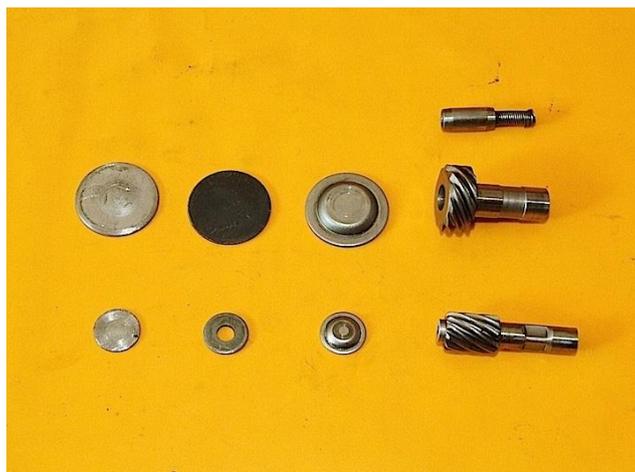
When you have removed the peenings the gears tap out and everything comes apart:

You can see the broken wire-stub, which I have knocked out of the big bevel-gear, the spiral-gear, the thrust-face and the packing shims that set the end-float.

This is an original Smiths drive, note that even though this has probably been run for many thousands of miles, the gears show no sign of wear and all that is wrong is the broken stub.

The thrust washers are made by an accurate press operation and they are smooth and have flat faces. They are also hard and like the gears more or less unworn.

Smiths crimped a ferrule over the end of the wire-stub, you can see it in the photo above. This has two ways to fail and I've seen both. The wire can "**screw-out**" of the ferrule or the ferrule can **slip** inside the bevel-gear. It's only a light push fit.

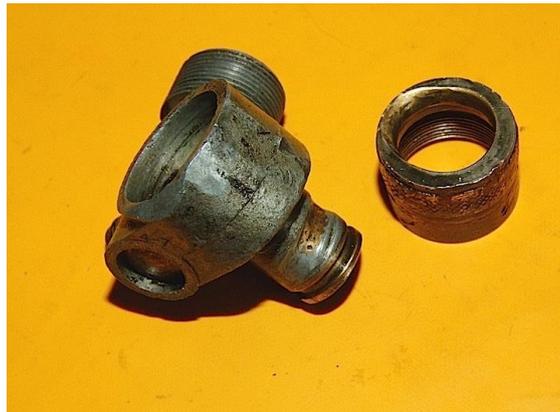
Here is another that has suffered abuse to its stem. In this case it has come undone from the transmission and has been running loose and rubbing on something. Again you can see how thin these are:

I fixed both of these drives with stem failure and wound up with a much stronger drive along the way. This is not really economic of course, but I did it anyway as a favour and to see if it would work.

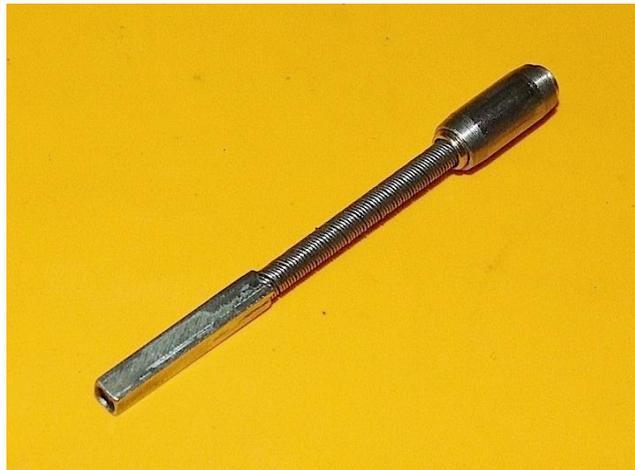
So I took a piece of 3mm square key-steel. drilled it to suit the speedo-cable and silver-soldered it on. This worked after a fashion but the wire was **weakened by the heat**, probably because of precious-metal embrittlement.

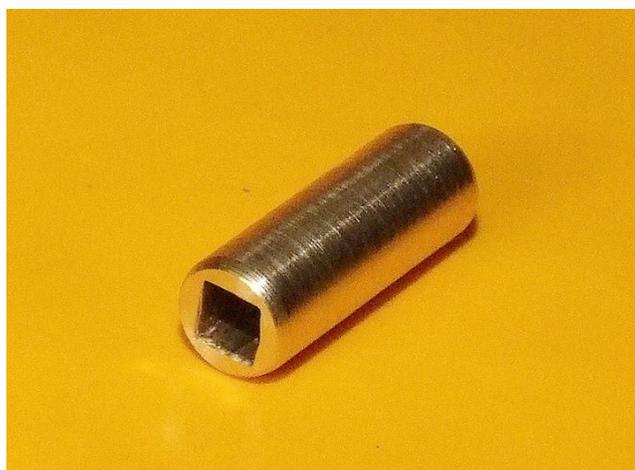
So I made this small brass part as a tight fit in the bevel-gear. It has 1/8in square hole in it, similar to the transmission, so a short length of key-steel will lock the parts together. These brass parts cannot be made economically by doing them one at a time. It's too fiddly. I make six at once and cut them off to size.

I added a **small O-ring** in order to retain the key-steel in the bevel-gear. This means there is a little freedom so that the key-steel “finds its place” in the parts, in the event that they are not perfectly in line. It damps vibration and means the key-steel is not just “rattling about” in there.

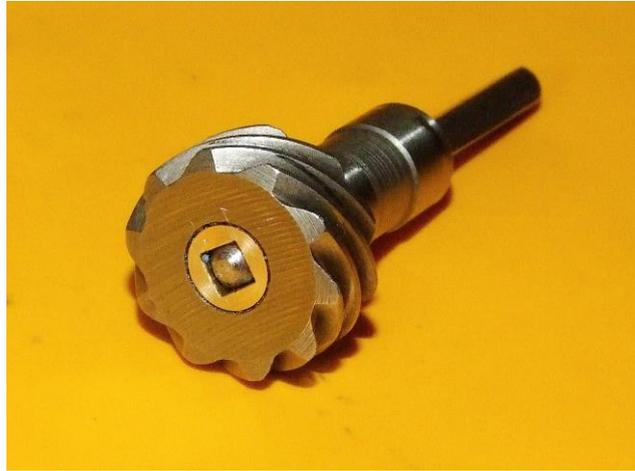
The rebuilt bevel gear looks like this, or rather a Smiths one does:

I made a batch like this and tried them out on willing members of the forum. They have been working fine for a couple of years now.

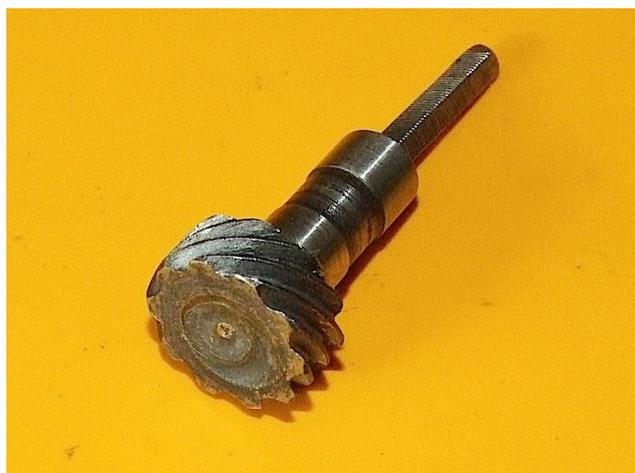
Here is the bevel gear from a well respected European manufacturer of reproduction parts. It's not too bad. The wire-stub is intact but it's been rotating in its ferrule. The ferrule is welded in place.

Lots of manufacturers try to do this. But such a weld is brittle and I easily knocked the ferrule out and repaired it like the Smiths one above. Note the much inferior finish on the gear-teeth compared to the Smiths one.

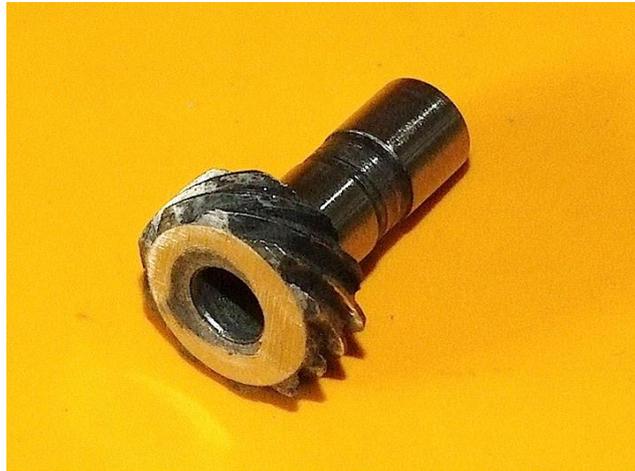
The gear-teeth get worse on the drives from the far-east. The teeth on this one have not been machine cut, they are just as they left the mould, when this item was cast. This one has had the ferrule knocked out also, you can see that there was no weld-penetration, just a surface mark where the weld was “stuck-on”.

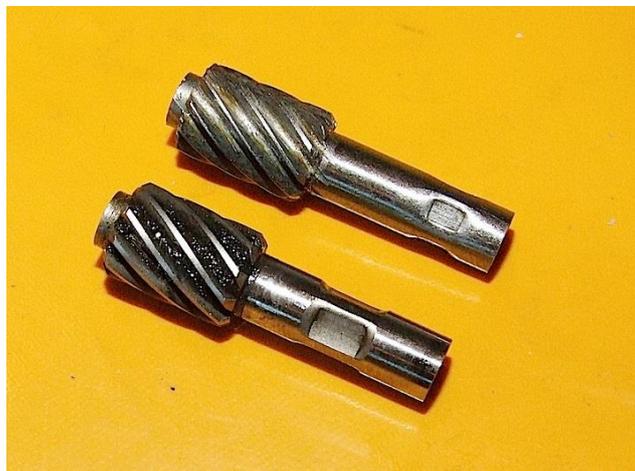
Enough of bevel gears and stubs, let's look at the spiral-gears. The lower one is a Smiths part, newly released from it's drive by the looks of it and the top one from a repro item made in the UK. Why do I think it came from the UK? I'll come back to that later on.

The top pinion came from a drive that refused to operate the speedo reliably. These pinions pick-up on the squared end of the speedo-cable. But they don't have a square hole. Not even the Smiths ones do.

Four dimples are pressed into them to approximate a square. This is OK provide you do actually make the dimples deep enough!

Note also the somewhat poor profile on the teeth.

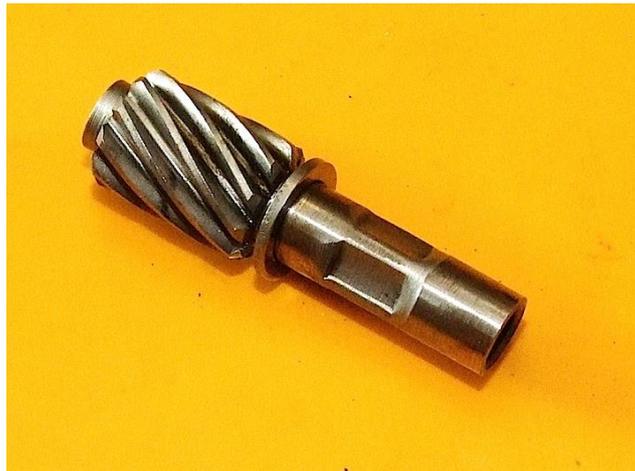
When I first opened a drive I did not notice that there was supposed to be a hardened washer in between the spiral-gear and the drive-body.

Well there is on the Smiths ones and usually on other European repros. Do I find them on the parts from the far-east? What do you think!

Without this washer the ends of the spiral teeth gradually cut into the soft drive-body. When you open them they are often full of metal chips.

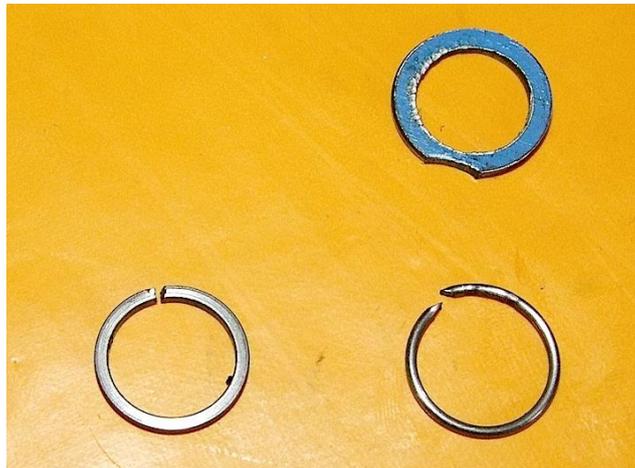
I use the nickname “blue-peril” for one of the most common reproduction items I come across. They twinkle blue seductively in your eyes because of the washer inside the knurled nut.

Just compare the spring-ring from one of these with the original item on the left. It's no wonder these usually have the nut loose in a bag when they find their way to me.

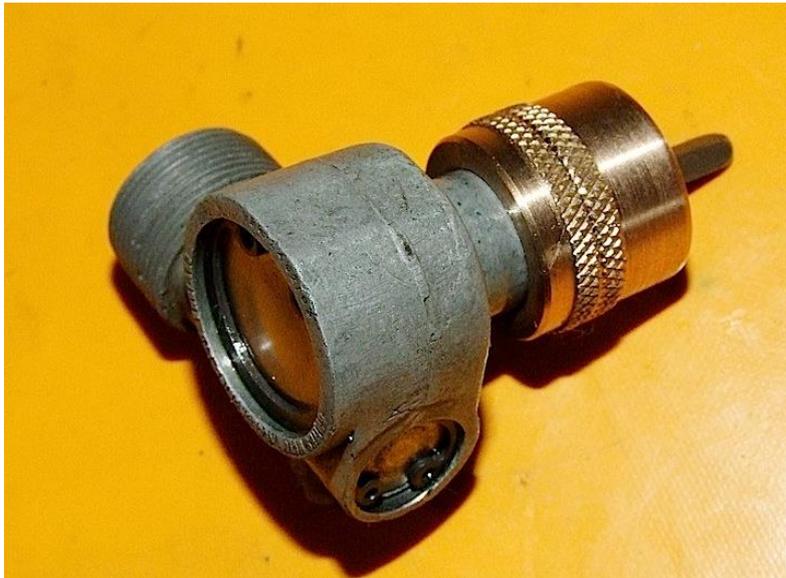
The Circlip method works well and the grooves are not too hard for me to cut.

One good thing, that I learnt from the reproduction parts however, is that you can fasten these drives together using Circlips.
